## HOME INSPECTION REPORT

Prepared For Exclusive Use By  
**Donna and Jesse Moreno**

For The Property Located At  
**634 Del Norte, Santa Maria, CA**

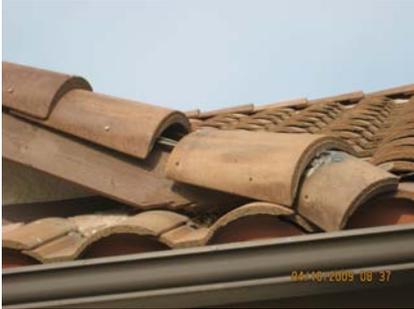
3.1 - DEFICIENT: There are two rake tiles at the N/E corner of the home that are not secured and have slipped, and need to be serviced/secured for safety and to help forestall the possibility of roof leakage.

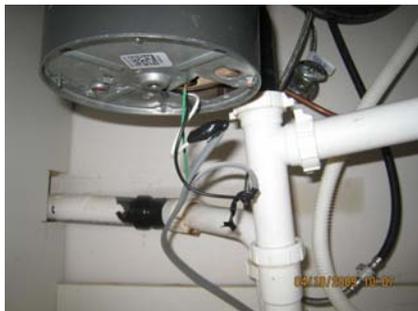
5.8 - DEFICIENT: The wiring under the kitchen sink for the garbage disposal is unsafe and needs servicing by an appropriately qualified electrician.

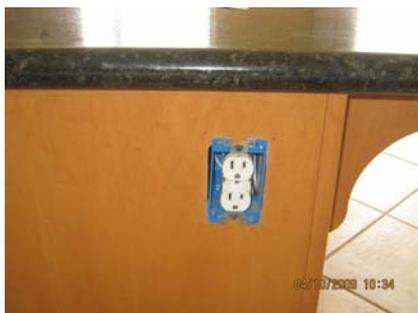
5.12 - DEFICIENT: There is an uncovered receptacle outlet at the west of the kitchen island that needs to be fitted with a cover for safety (easily remedied).

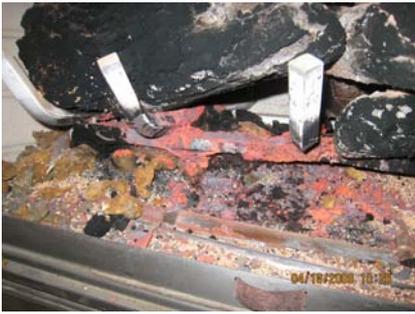
8.5 - DEFICIENT: The log grate at the fireplace is damaged, and you may wish to have it serviced or replaced.

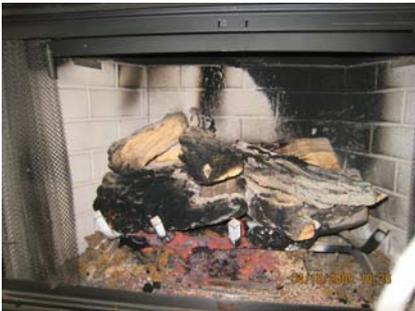
8.7 - DEFERRED: There are heavy carbon deposits on the gas logs which indicate incomplete combustion and a potentially unsafe condition, and we recommend further evaluation by an appropriately qualified specialist.

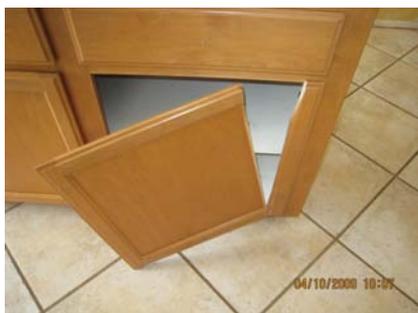
9.9 - DEFICIENT: The kitchen cabinetry has some damage and will need repair or replacement.

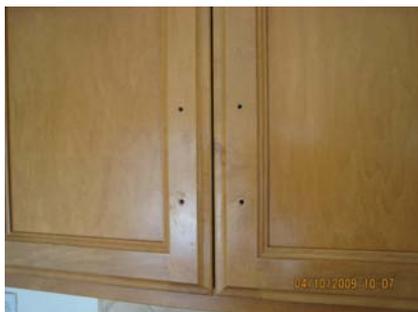
9.10 - DEFICIENT: The cabinet door handles are missing throughout the home and need replacement.

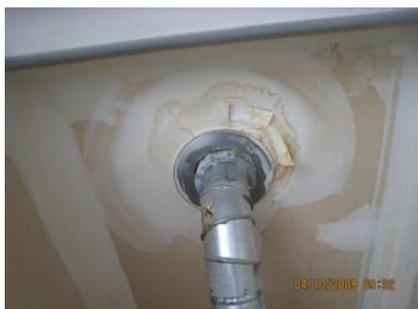
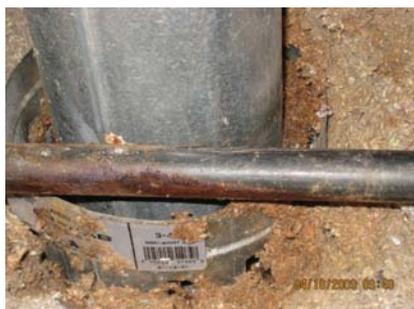
10.5 - DEFERRED: There are water stains around where the water heater vent pipe passes through the garage ceiling that is most likely the result of condensation accumulating on the gas line directly adjacent to the vent pipe. You should have this condition corrected to help prevent moisture damage and possible mold growth.

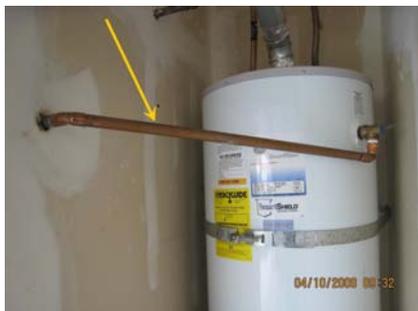
10.7 - PREVENTIVE: The discharge line from the temperature and pressure relief (TPR) valve has been incorrectly plumbed uphill, which can allow any discharge to remain in the line and damage the valve, and the line should be correctly plumbed downhill for safety.
